## **Camdenton TCE Sites Camdenton, Camden County, Missouri**

**PUB3032 February 2022**

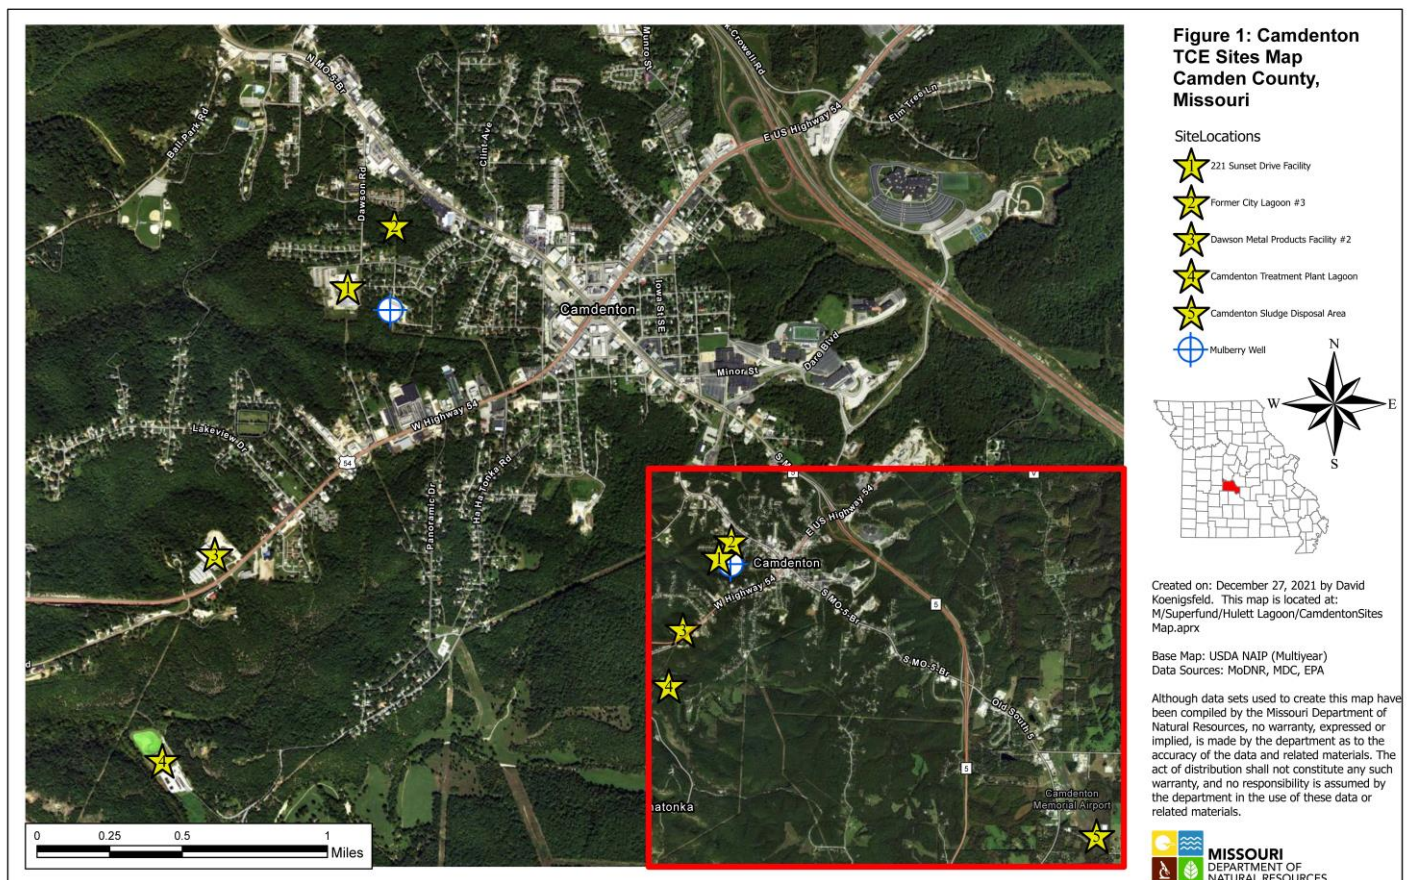
## Site Location Aerial Map

The site map below shows six impacted areas or sites in the Camdenton area: the currently vacant 221 Sunset Drive facility, the Former City Lagoon #3, the Mulberry Well, the Dawson Metal Products Facility #2, the Camdenton Treatment Plant Lagoon, and the Camdenton Sludge Disposal Area. These six sites have undergone varying degrees of investigation and cleanup activities.
